Blanket Bog Track Trial

Moor House NNR

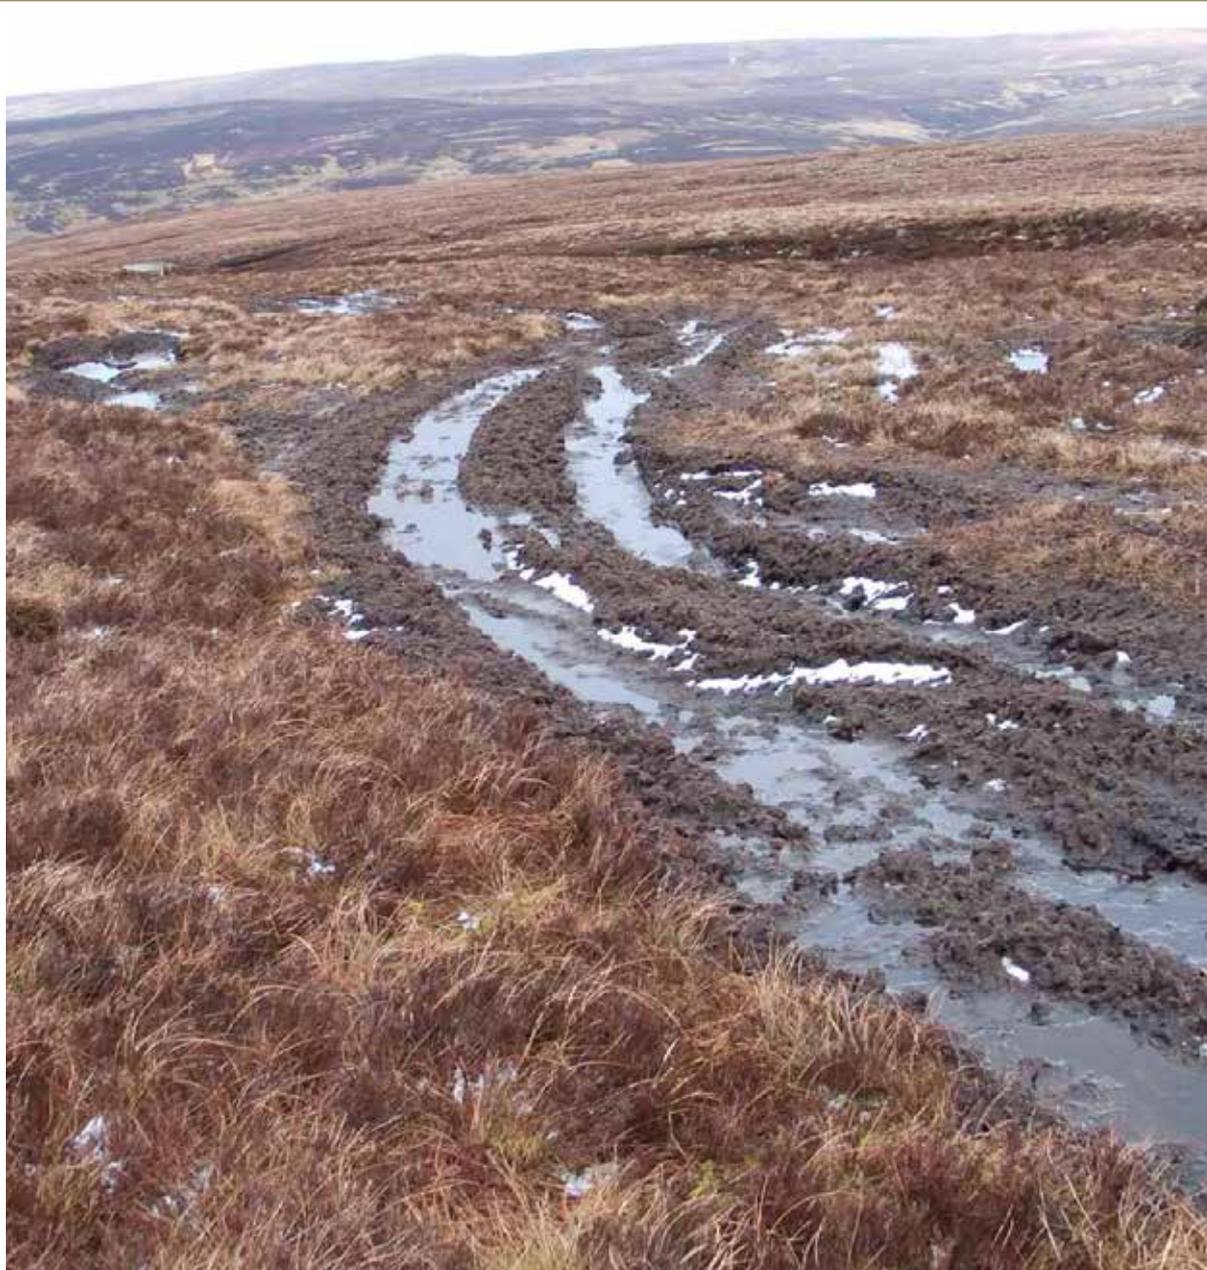
Fig 1. Braiding and rutting damage to peatland with no protective surface.

Both track surfaces offered protection from damage to the peat surface. Rutting did occur on the lower section and turning area of the no-surface route section after 24 passes. This had very light use during the trial (twice per month) and was stopped early (12 months not 18) due to the damage being caused. It is precisely this damage that practitioners and conservationists seek to avoid by finding a pragmatic solution.

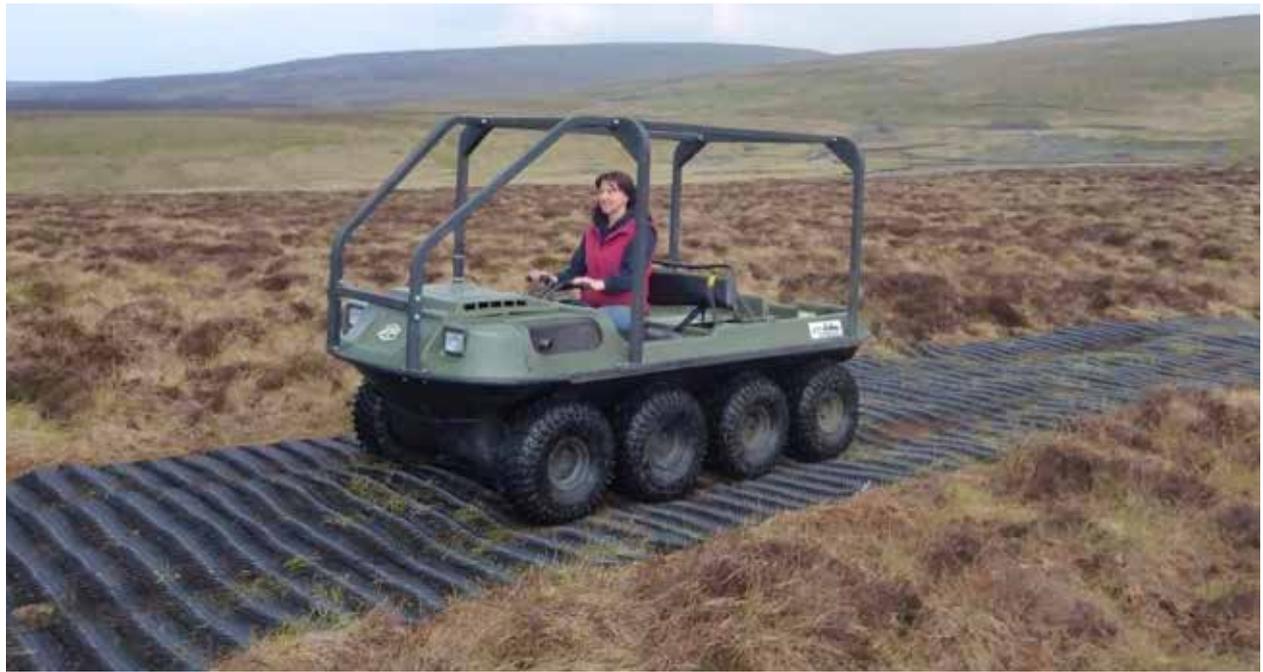
Plastic mesh track trial with the Argocat (but also suitable for quad bikes)

- Plastic mesh track laid and driven on by an argocat (but also suitable for quad bikes)
- A heavier duty wooden construction suitable for heavier vehicles such as 4x4s

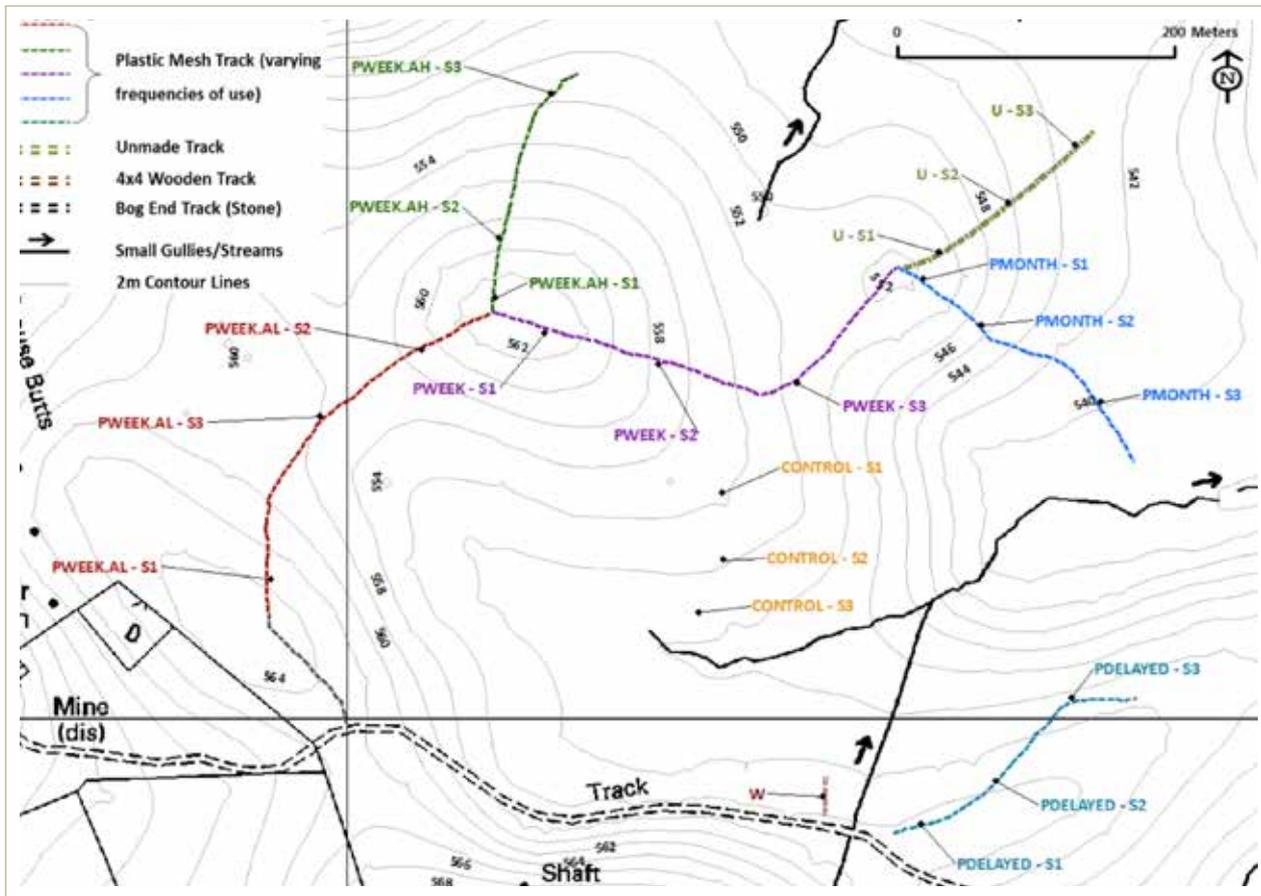
Fig 2 shows the layout of the tracks, level of use and topographical positions over the contours.

Fig 2 (opposite top) shows the layout of the tracks, level of use and topographical positions over the contours.

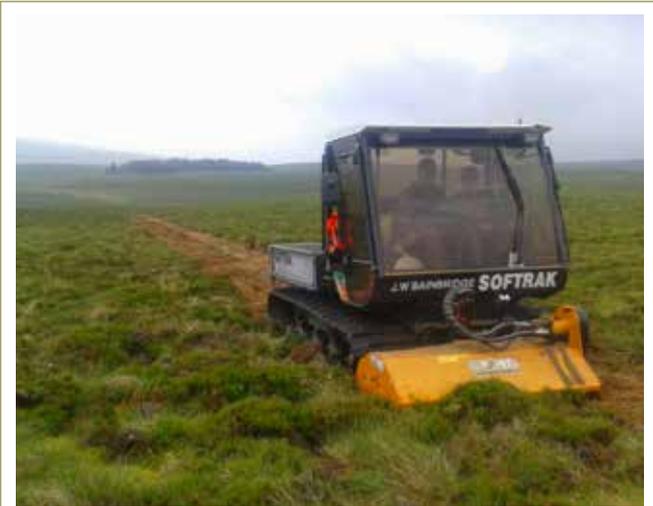
Fig 3. Route of mesh track was cut.

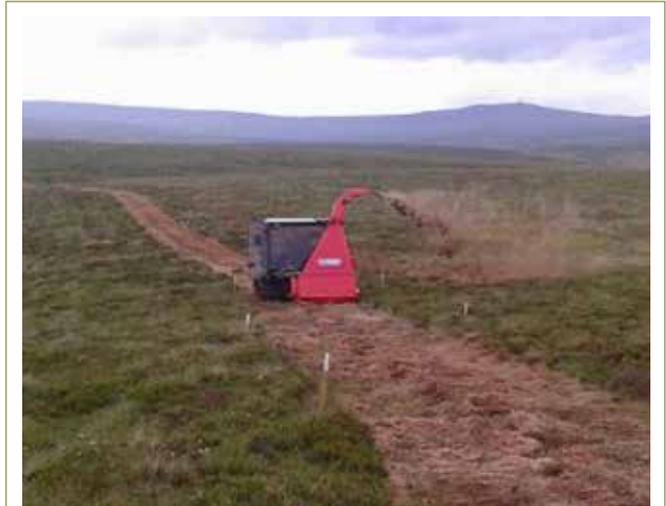
Fig 4. Brush was collected and blown to the side.

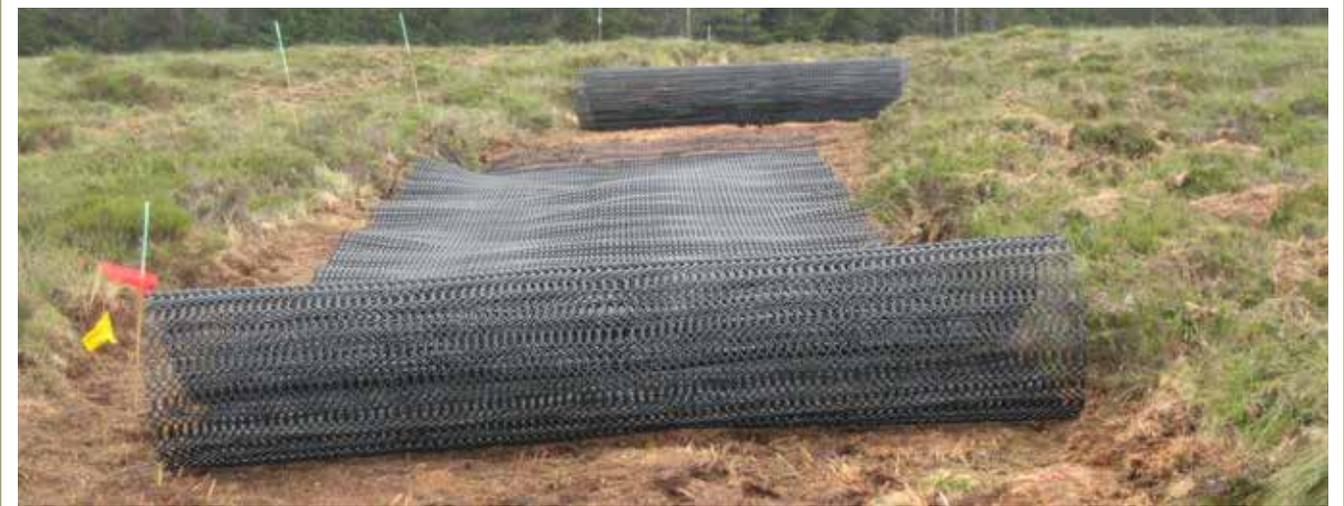
Fig 5. Mesh was rolled out.

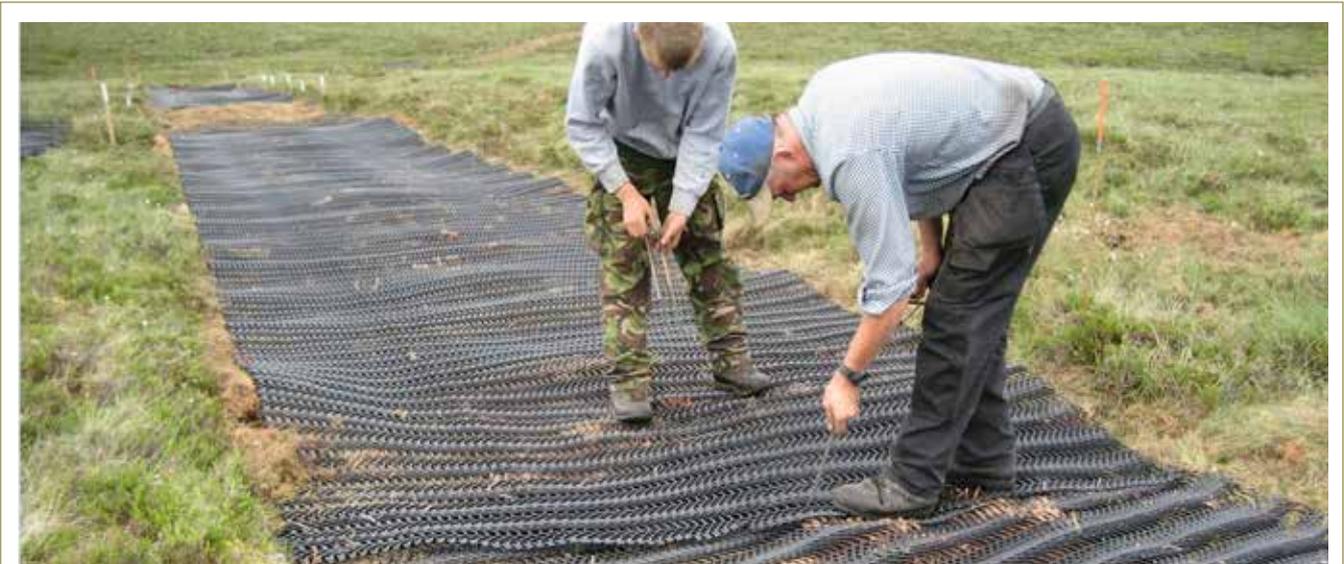
Fig 6. Mesh was pinned in place with 300mm steel U shaped pins.

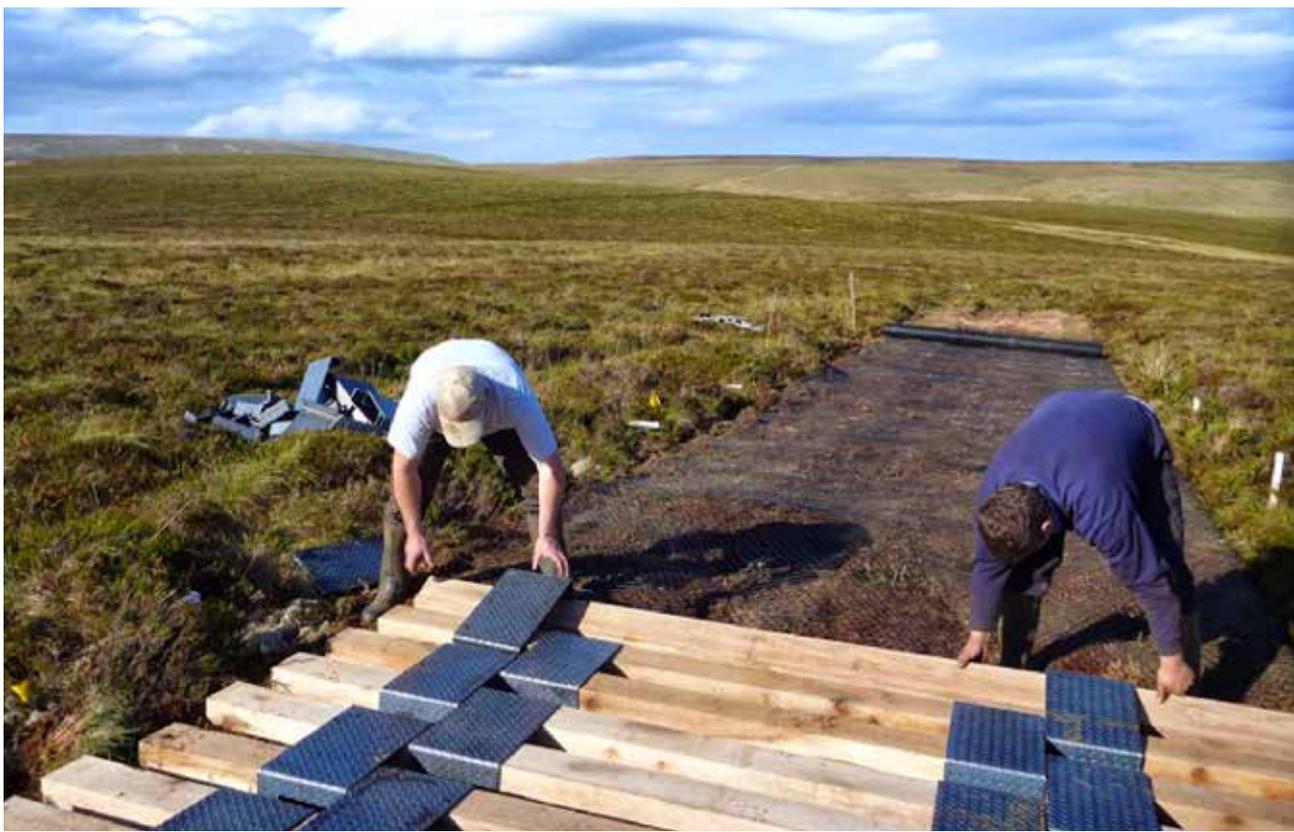
Fig 7. Wooden track being laid after vegetation was cut and removed and plastic grid rolled out.

This track was constructed from hardwood planks spaced to leave a gap the same width as the plank connected together with folded steel links which also act as the main running surface. A plastic grid was spread on the cut vegetation to spread the load of the plank construction laid on top. John Carrick designed, supplied and laid the track free of charge for which the project partners are very grateful.

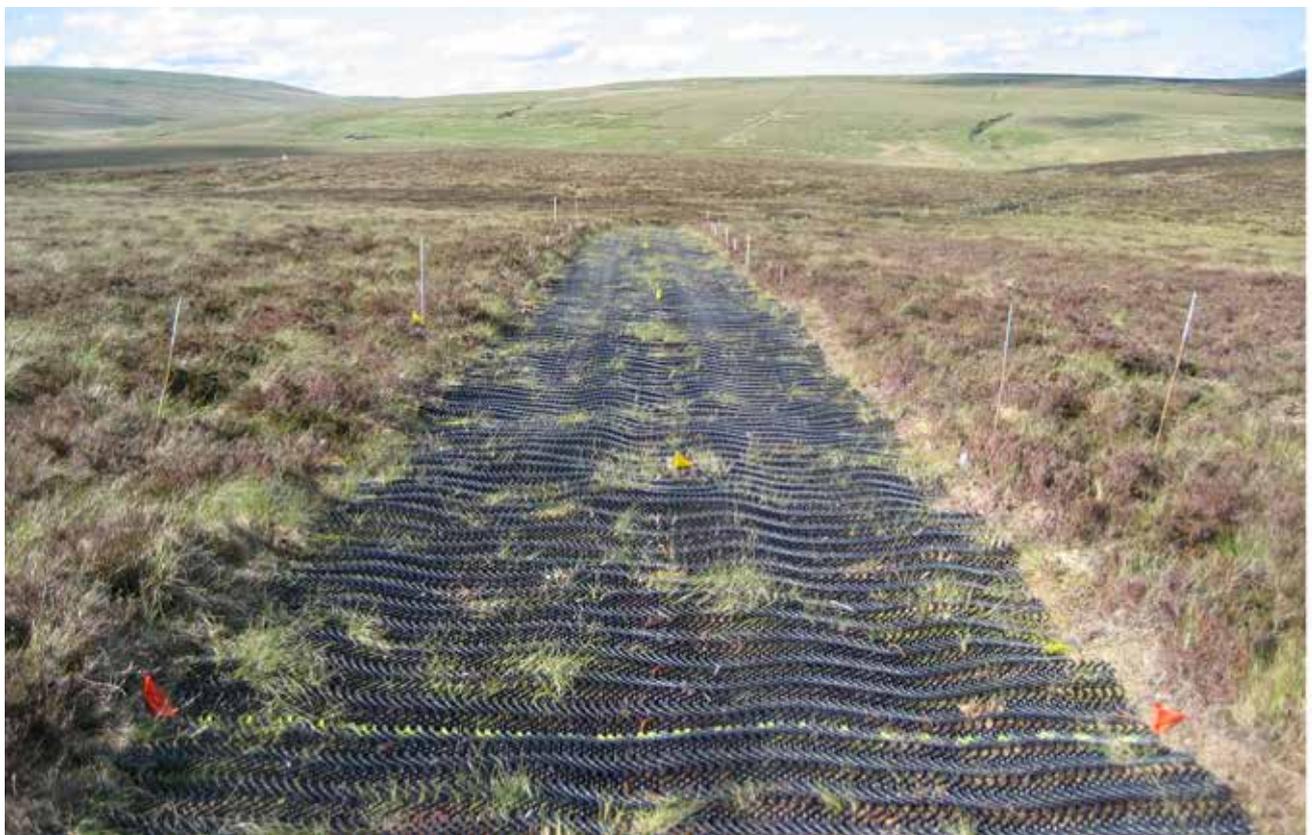
Fig 8. May 2014 10 months after track installation (K. McKendrick-Smith, 2014)

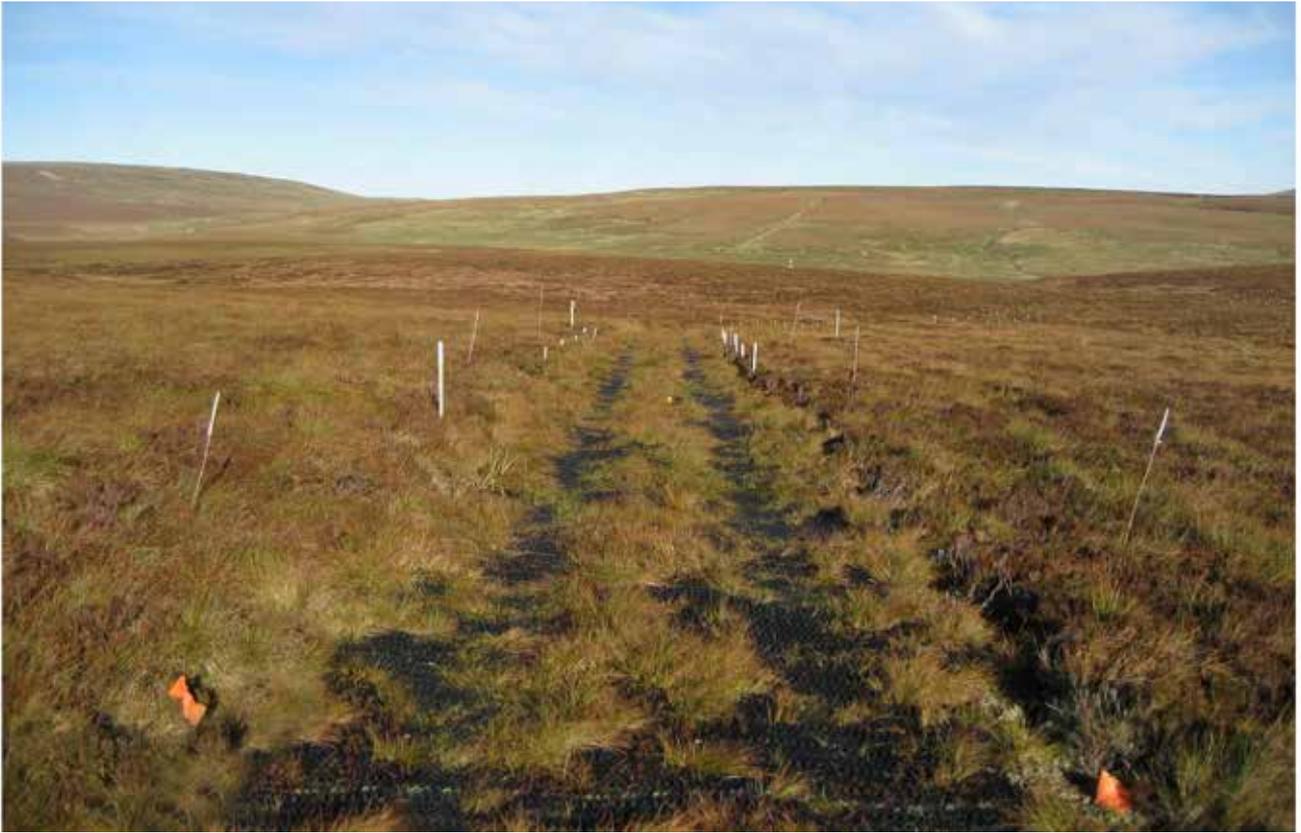
Fig 9. October 2015 2 years 3 months after track installation (K. McKendrick-Smith, 2014)

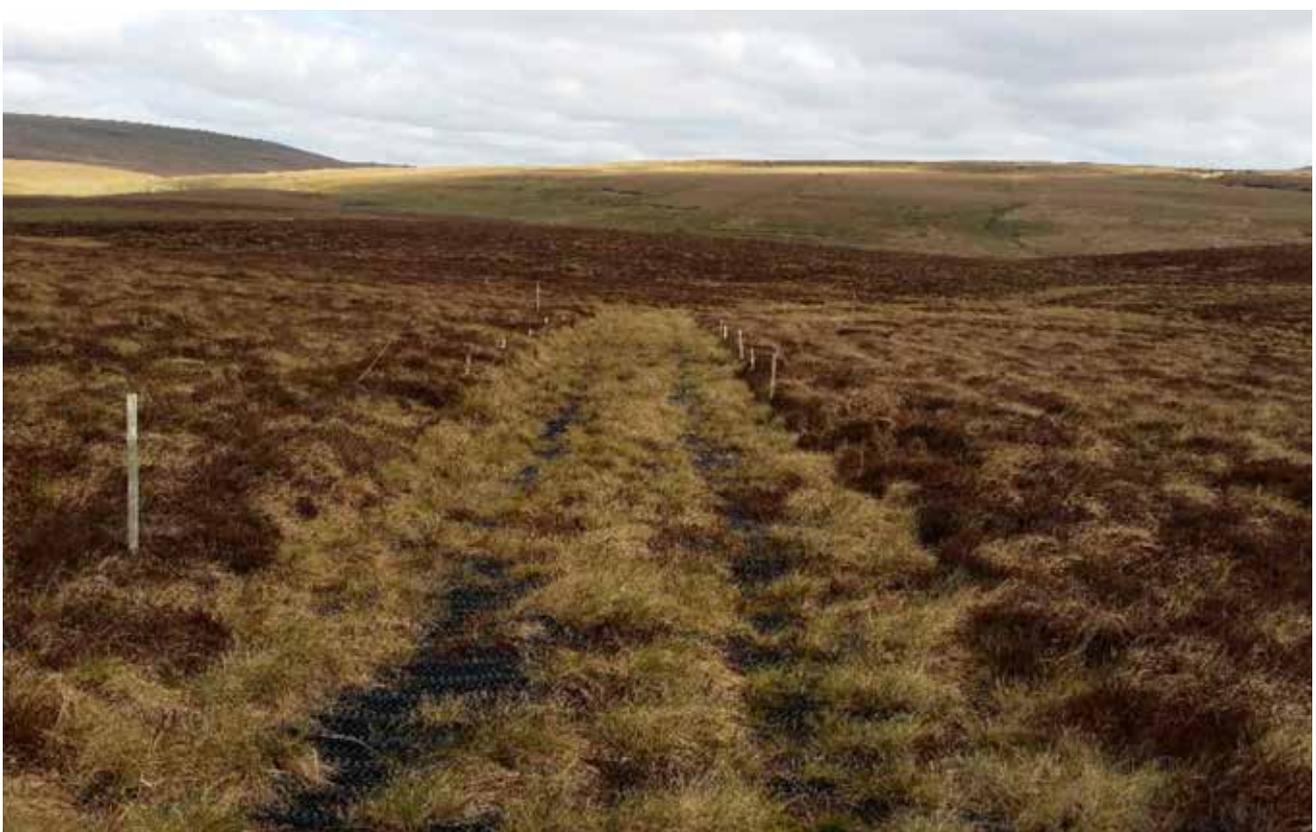
Fig 10. April 2017 3 years 9 months after track installation (K. McKendrick-Smith, 2014)

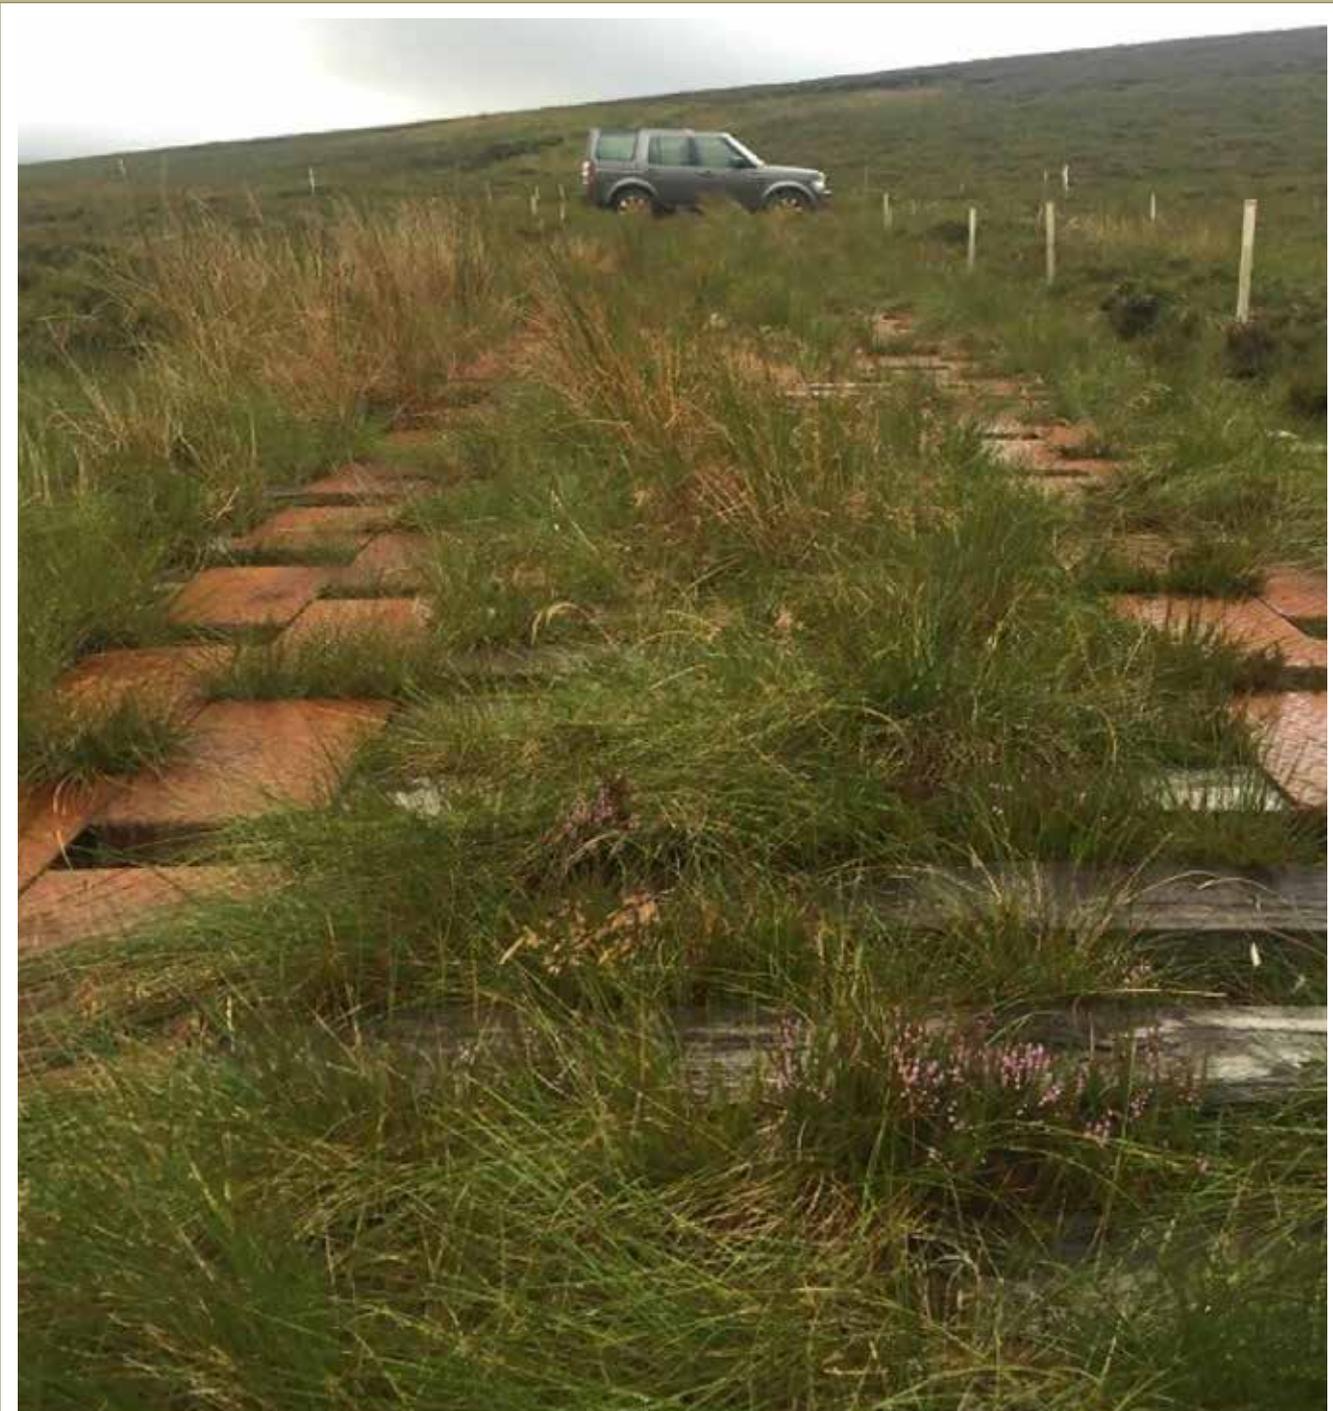
Fig 11. April 2017 3 years 9 months after track installation (K. McKendrick-Smith, 2014)
